**COMPORTAMENTO SISMICO DI UN TELAIO
CONTROVENTATO IN ACCIAIO DOTATO DI PROTEZIONI
PASSIVE AL FUOCO**

**SEISMIC BEHAVIOUR OF A STEEL BRACED FRAME
EQUIPPED WITH PASSIVE FIRE PROTECTIONS**

The paper describes the experimental behaviour of a braced steel frame equipped with passive fire protections subjected to the seismic action as a part of the European EQUFIRE project. The structure was designed for reference peak ground acceleration equal to 0.186g, soil type B and type 1 elastic response spectrum according to Eurocode 8. Experimental tests were performed at the ELSA Reaction Wall of the Joint Research Centre (JRC) according to different configurations. In fact, bare elements without fire protection and specimens with three fire protection solutions, i.e. conventional and seismic-resistant boards as well as vermiculite spray, were considered. The experimental tests were performed by means of the pseudodynamic technique on a full-scale specimen physically representing the first storey of the building, while the upper three storeys were numerically simulated. The damage of passive fire protections applied on the bracing and one column are reported in order to give insight into a f

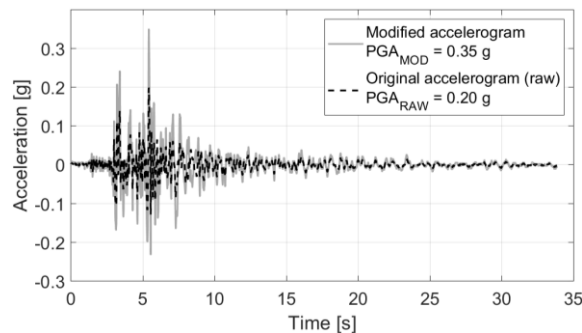
Fig. 2. Comparison between the original and modified accelerogram for the FFE simulation

In order to perform non-linear time-history analyses, it was fundamental to model the seismic hazard through adequate selection and scaling of ground motion records. In this respect, a set of fifteen accelerograms for the significant damage limit state (SD) was selected considering the type of spectrum, magnitude range, distance range, style-of-faulting, local site conditions, period range, and ground motion components using the INGV/EPOS/ORFEUS European Strong motion Database [21]. The accelerograms were modified to match the target spectrum in the period range of 0.4÷0.9s that includes the fundamental period of the structure equal to 0.67 s. Among the fifteen accelerograms, the one shown in Fig., known as the Patras earthquake was used in this section as an example for the FFE test. The earthquake occurred on July 14, 1993 with a magnitude of 5.4. This accelerogram was chosen in order to be the same accelerogram used during the all EQUFIRE experimental tests, based on three main requirements:

- The selected accelerogram had to cause significant damage to the bracings.
- The horizontal displacement of the first floor had to be equal or lower than ± 30 mm to be compatible with the horizontal actuator stroke of the BAM furnace.
- The axial force of the internal columns at the beginning of the second floor had to be below 1000 kN to be compatible with the actuators used to impose the vertical loads on the specimen at the ELSA Reaction Wall.
